## Summary

*Summary of Dams in the DuPage River-Salt Creek River Study Area***Salt Creek** (dams are ordered north to south)

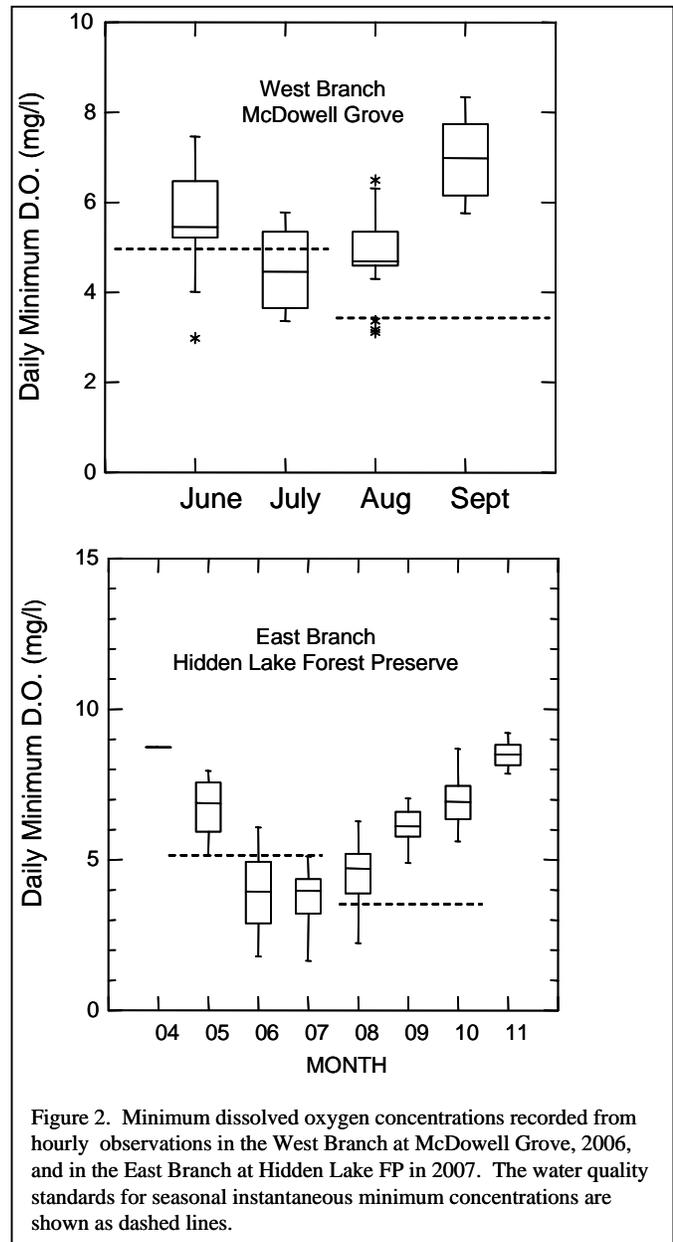
Figure 2. Minimum dissolved oxygen concentrations recorded from hourly observations in the West Branch at McDowell Grove, 2006, and in the East Branch at Hidden Lake FP in 2007. The water quality standards for seasonal instantaneous minimum concentrations are shown as dashed lines.

These limitations do not act singly, but often work in concert. For example, the effects of nutrient enrichment were most pronounced in impounded sections of the mainstems, where wide swings in diel dissolved oxygen concentrations often resulted in hypoxic conditions. Nowhere was this problem more manifest than in the dam pool at McDowell Grove on the West Branch, the dam pool at Churchill Woods on the East Branch where dissolved oxygen concentrations fluctuated by as much as 15 mg/l, and at the Hidden Lake Forest Preserve on the East Branch where minimum dissolved oxygen concentrations frequently fell below water quality standards during the summer months (Figure 2). Numerous stormwater detention ponds and other small impoundments in the headwaters contributed loadings of ammonia, total Kjeldahl nitrogen and oxygen demanding substances resulting in higher-than normal ambient concentrations for these parameters. Comparing the concentrations of these substances to total phosphorus concentrations by stream size reveals the spatial contribution from the diffuse headwater sources relative to point source loadings (Figure 3). Phosphorus concentrations in excess of 0.5 mg/l were the domain of treated effluent, and most of the publicly owned treatment plants in the survey area discharged to streams larger than 2 square miles in drainage area. Evidence for the stress created by urban/suburban stormwater was also manifest in elevated concentrations of polycyclic aromatic hydrocarbons (PAHs) in sediment samples collected throughout the study area. PAHs build up on road surfaces as a result of incomplete petroleum combustion and leakage. The concentrations of PAHs detected in sediment samples frequently exceeded levels where effects on benthic organisms are likely.

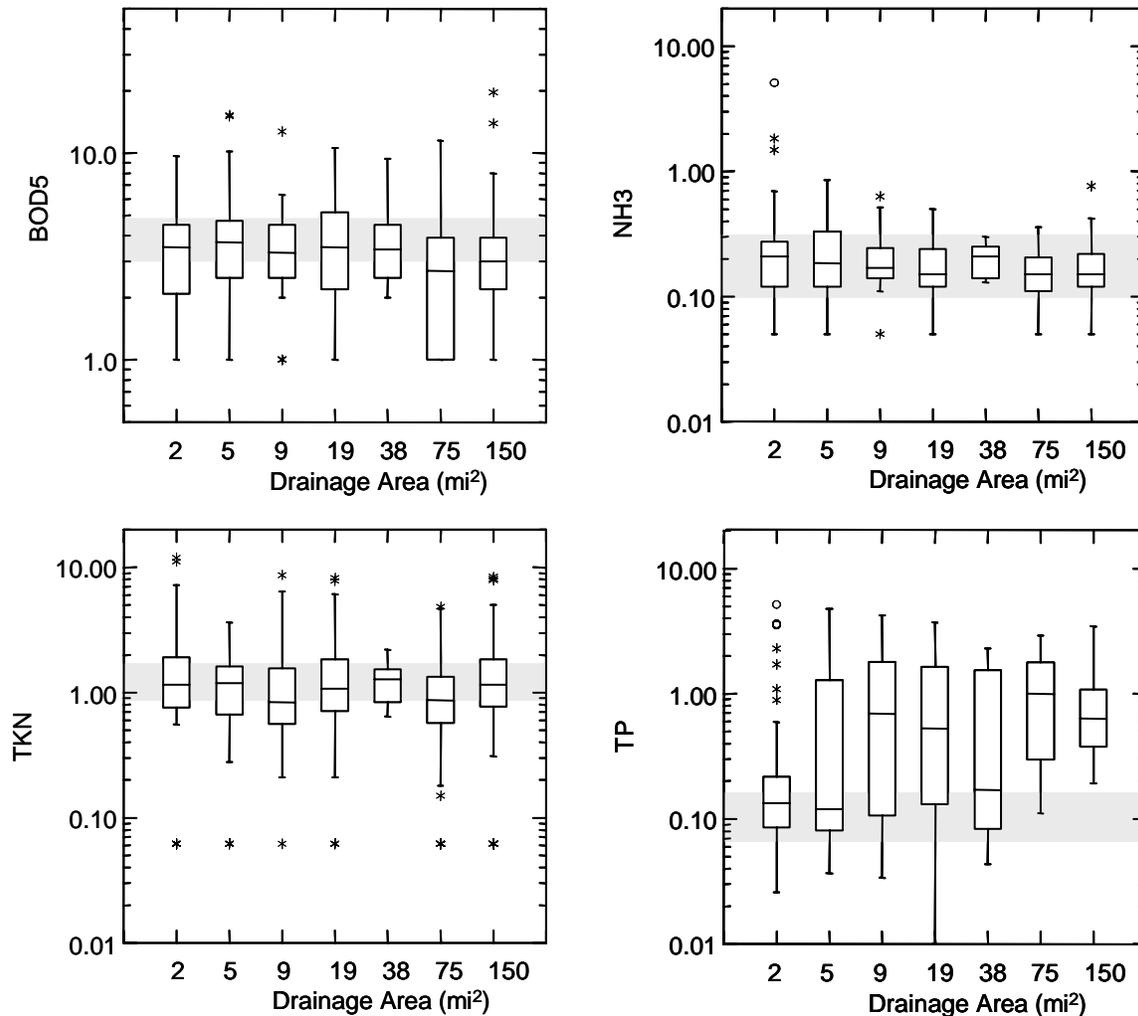
Figure 3. Concentrations of selected water quality parameters, in mg/l, measured during the Salt Creek - DuPage River watershed survey stratified by geometric stream size category. Boxes enclose the lower and upper quartiles (25<sup>th</sup> and 75<sup>th</sup> percentiles), whiskers encompass the range of the data, and outliers, shown as asterisks, are more than twice the interquartile range. The shaded area in each plot shows the upper range of concentrations typical of unpolluted waters (U.S. EPA 2004, Ohio EPA 1999, Wetzel 1981).

Concentrations of total dissolved solids (TDS) greater than 1000 mg/l were noted in water quality samples collected from headwater sites, especially for the Arlington Heights Branch and the Salt Creek mainstem. Concentrations of TDS greater than 1000 mg/l are toxic to certain macroinvertebrates, most notably mayflies. While specific source identification was beyond the scope of this study, treated effluent from point sources was clearly ruled-out.

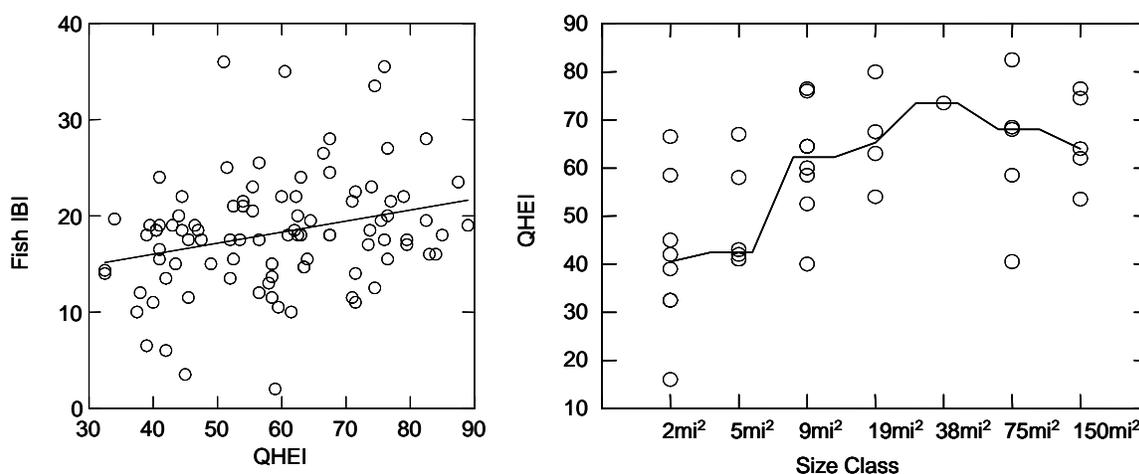
Figure 4. Left Panel - Fish Index of Biotic Integrity (IBI) scores for the Salt Creek - DuPage River study area plotted against Qualitative Habitat Evaluation Index (QHEI) scores. The trend line is from an ordinary least squares regression. Right Panel - QHEI scores for the -DuPage River-Salt Creek study area plotted by geometric stream size category. The trend line is drawn through the median value for each size category.

The biological communities were not, however, completely overwhelmed by the high degree of suburbanization in these watersheds, as habitat quality explained a significant amount of the variation in the biological indices (Figure 4). Degraded stream habitat with minimal function beyond water conveyance was frequently noted at headwater sites; however, habitat quality along the lower West Branch, East Branch and Salt Creek mainstems, exclusive of dam pools, was rated as good to excellent. Furthermore, biological communities sampled within forest preserve lands tended to score better than non-buffered sites. These results suggest that habitat restoration (i.e., both stream and riparian) is likely to have both a direct benefit in terms of biological condition, and an indirect benefit by improving assimilative capacity.

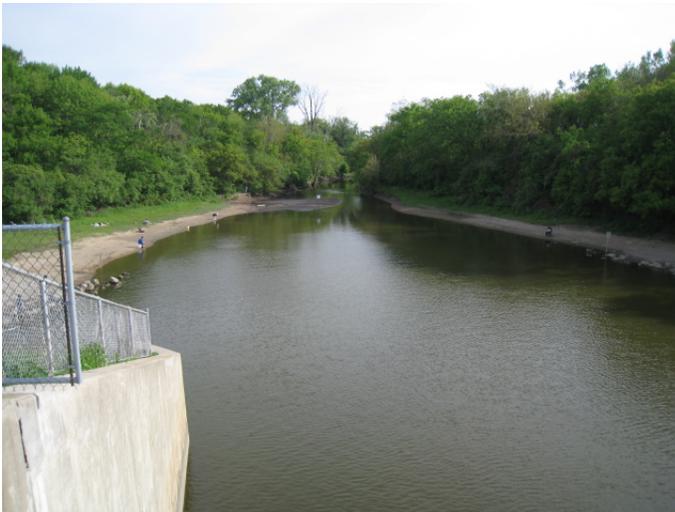
Section of the Busse Woods Impoundment, looking upstream from spillway

**Busse Woods Reservoir South Dam:** The Busse Woods Reservoir South Dam is located on Salt Creek within the Busse Woods Forest Preserve. The dam is owned and maintained by the Illinois Department of Natural Resources Office of Water Resources and is located within Elk Grove Village. Access is best granted off of Arlington Heights Road to picnic groves 26 and 27 or 32.

The dam was built for flood control and recreational purposes in 1977. The dam is of earthen construction and has a height of 23 feet and is 1381 feet long. The reservoir has a surface area of 415 acres.

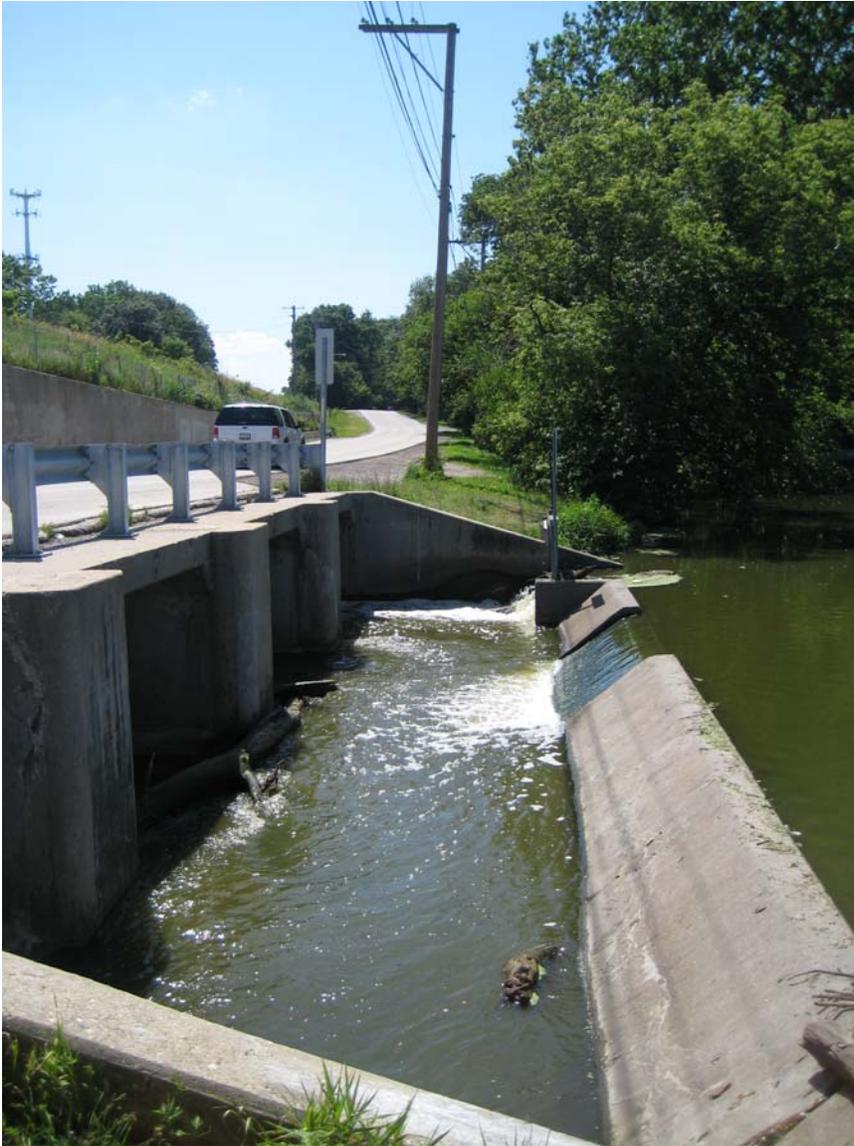
The dam was originally built in the 1930's as part of the Works Progress Administration. It was rebuilt with the reconstruction of Crescent Boulevard in 1983. The dam is a concrete gravity dam with a dewatering gate on the right side. The dam is 50 feet across and has a total height of 3.5 feet.

The impoundment created by the dam is approximately 31 acres in size.

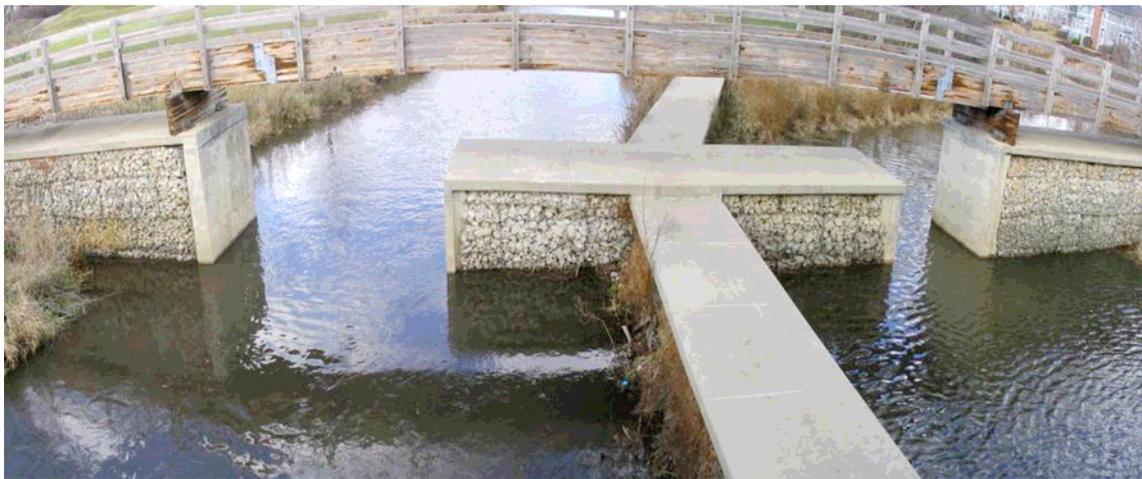
The dam was constructed in 1989 to provide on line stormwater detention for the adjacent development. The dams are gravity structures consisting of rock filled gabions that impound water at a greater rate as the flow rate increases. The East Branch structure is 20 feet wide while the Prentiss Creek structure is 10 feet wide.

The dam creates a minor impoundment only on Prentiss Creek depending on flow conditions (storm control structure).

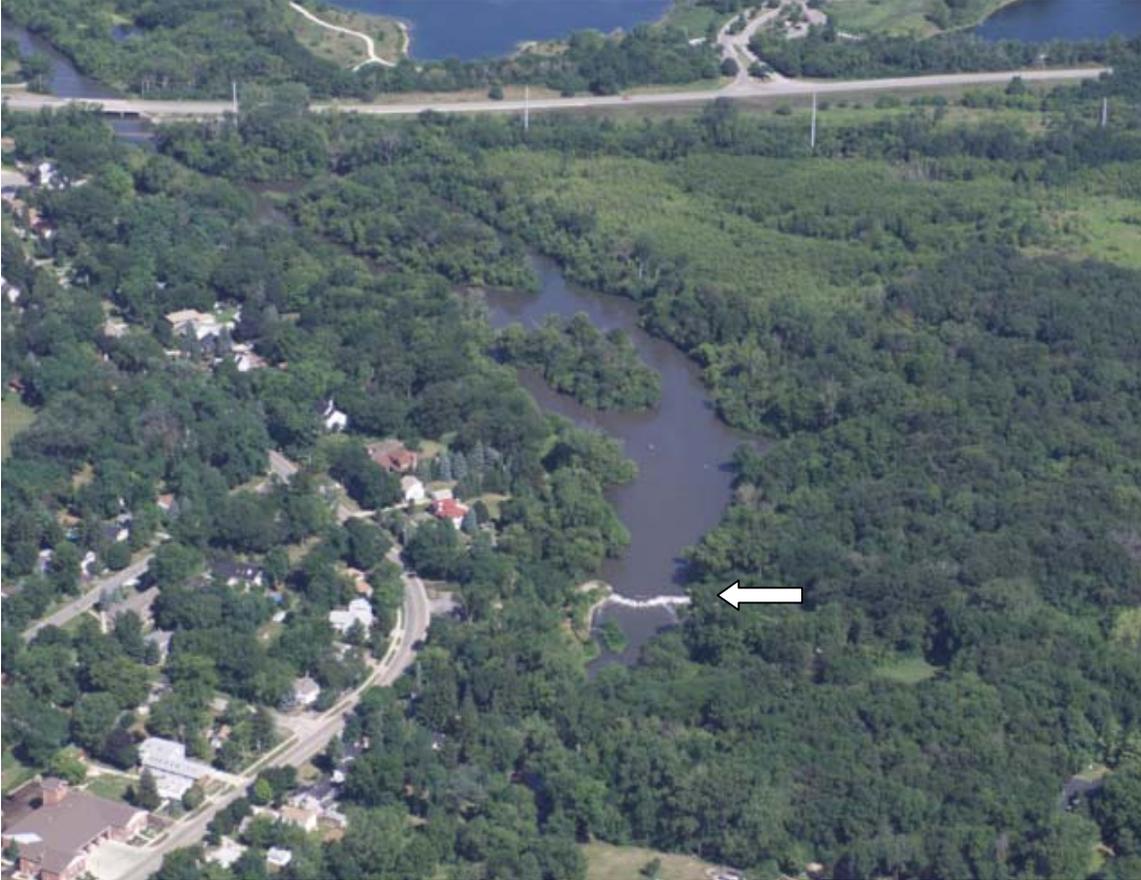
Aerial view of the Warrenville Dam looking upstream (2001). Dam highlighted by arrow.

**Warrenville Grove Dam:** The Warrenville Grove Dam is located on the West Branch of the DuPage River within the Warrenville Grove Forest Preserve in the Village of Warrenville. The dam is one third of a mile upstream of Warrenville Road. The low head dam is owned by the Forest Preserve District of DuPage County (FPDDC) and is approximately 70 years old. Access to the dam is best gained via the Forest Preserve Parking Lot on Batavia Avenue.

The dam was constructed of limestone in a stair step configuration with a concrete foundation and headwall on the upstream face of the spillway. The dam is 107 feet across with a curving spillway face that has a total crest length of about 125 feet. The dam has a total height of 8.5 feet above the downstream river channel bottom and a total hydraulic height of 5.7 feet (from spillway crest to tailwater elevation under average flow conditions).

The dam also features a mill race that was partially retrofitted in 1995 to function as a fish ladder and canoe chute. The impoundment created by the Warrenville Grove Dam is approximately 1.2 miles in length and covers about 16.9 acres.

The dam was constructed by the Civilian Conservation Corps between 1936 and 1938. The dam was designed by the National Park Service and was part of a dam building program in the region that was conveyed as a way to “reduce bank erosion”. The site for the dam was chosen due to the presence of an older abandoned dam in the same location that provided a power source to mills between 1847 and 1897.

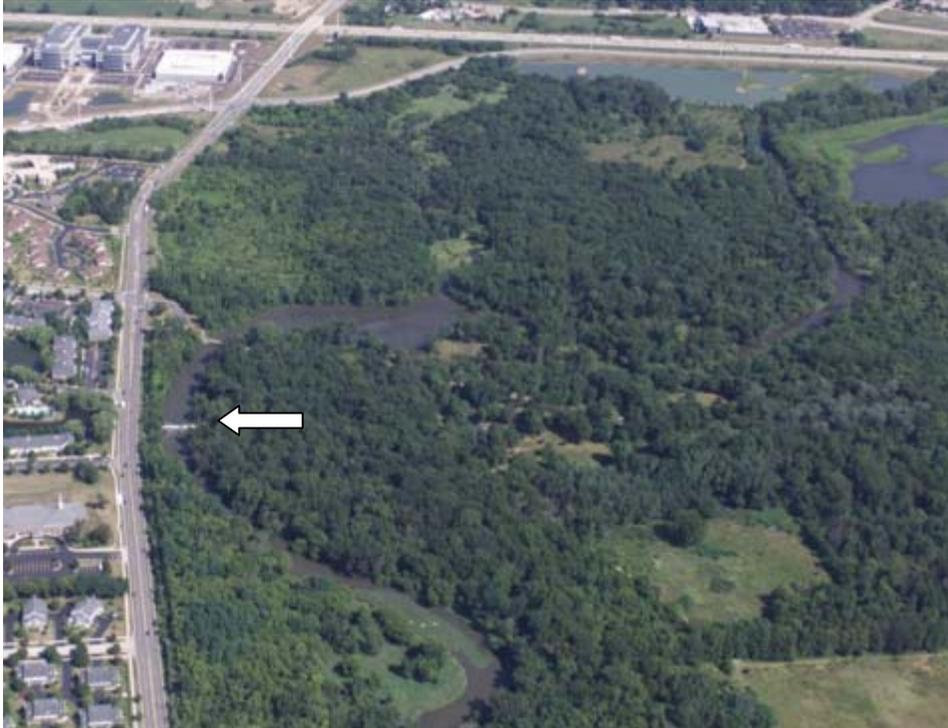
Aerial view of McDowell Grove Dam, looking upstream (2001). Dam highlighted by arrow.

**McDowell Grove Dam:** The McDowell Grove Dam is located on the West Branch of the DuPage River within the McDowell Grove Forest Preserve in unincorporated DuPage County. The dam is one mile downstream of Interstate 88. The low head dam was built by the Civilian Conservation Corps and is approximately 70 years old. Access to the dam is best granted from the Forest Preserve Parking Lot located within McDowell Grove Forest Preserve.

The dam is constructed of limestone and is a run of the river structure. The stone spillway is likely cemented into place and supported by a reinforced concrete foundation and retaining wall on the upstream face. The dam has a concrete and stone fish ladder integrated into the spillway where it meets the left abutment. The dam is 96 feet across. The dam has a total height of 8.5 feet above the downstream river channel bottom and a total hydraulic height of 5.7 feet (from spillway crest to tailwater elevation under average flow conditions).

The impoundment created by the dam is approximately 2900 feet long and covers an area of 8 acres. Dam removed mid 2008 although impoundment remains due to the installation of a temporary dam.

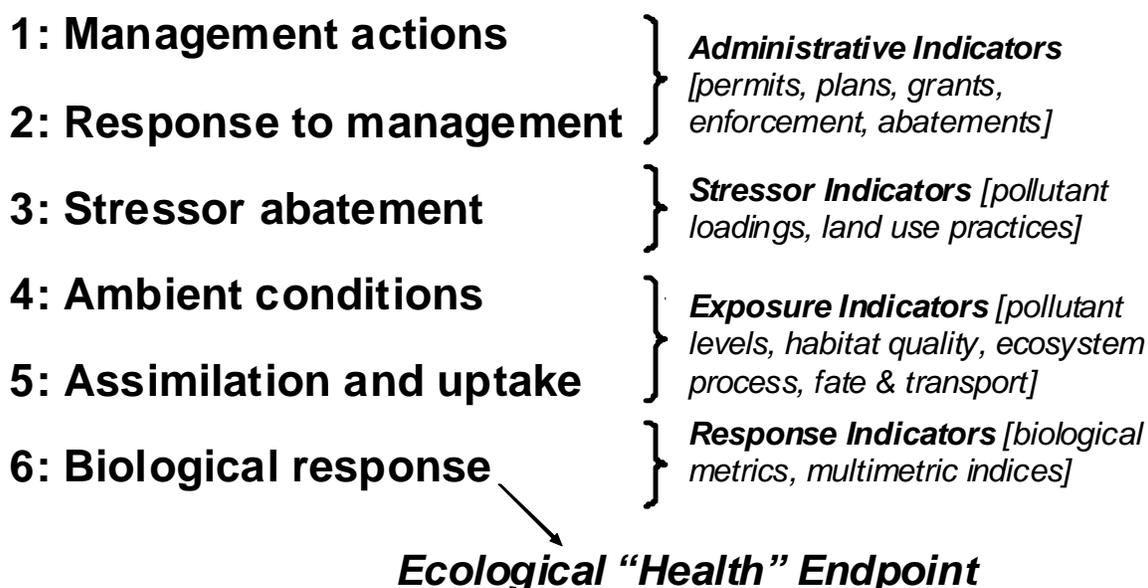
Figure 8. Hierarchy of administrative and environmental indicators which can be used for water quality management activities such as monitoring and assessment, reporting, and the evaluation of overall program effectiveness. This is patterned after a model developed by U.S. EPA (1995) and further enhanced by Karr and Yoder (2004).

- 1) actions taken by regulatory agencies (permitting, enforcement, grants);
- 2) responses by the regulated community (treatment works, pollution prevention);
- 3) changes in discharged quantities (pollutant loadings);
- 4) changes in ambient conditions (water quality, habitat);

- 5) changes in uptake and/or assimilation (tissue contamination, biomarkers, assimilative capacity); and,
- 6) changes in health, ecology, or other effects (ecological condition, pathogens).

In this process the results of administrative activities (levels 1 and 2) can be linked to efforts to improve water quality (levels 3, 4, and 5) which should translate into the environmental “results” (level 6). An example is the aggregate effect of billions of dollars spent on water pollution control since the early 1970s that have been determined with quantifiable measures of environmental condition (Yoder et al. 2005). Superimposed on this hierarchy is the concept of stressor, exposure, and response indicators. *Stressor* indicators generally include activities which have the potential to degrade the aquatic environment such as pollutant discharges (permitted and unpermitted), land use effects, and habitat modifications. *Exposure* indicators are those which measure the effects of stressors and can include whole effluent toxicity tests, tissue residues, and biomarkers, each of which provides evidence of biological exposure to a stressor or bioaccumulative agent. *Response* indicators are generally composite measures of the cumulative effects of stress and exposure and
